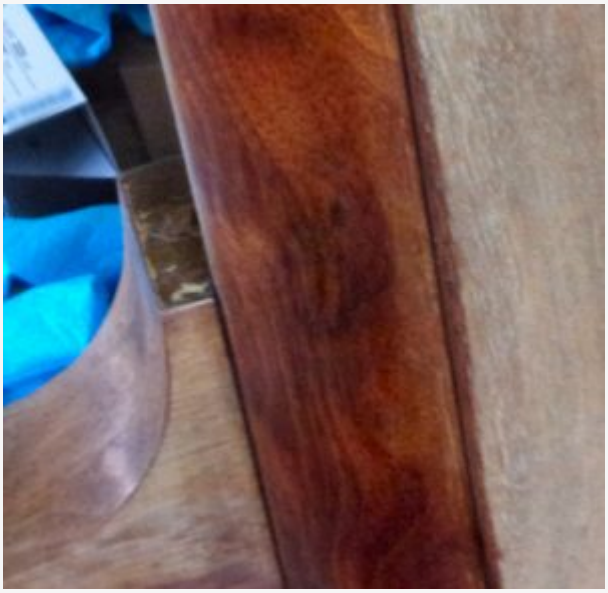
The completed patch

The patch isn’t perfect (very rarely will a patch be completely invisible), but it looks pretty good. You know it is working well when you have to pause in the work to re-locate the patch.

The piano had a deep dent near an its right-front round-over corner. Such a damage is usually best repaired with a veneer patch. Being in such a visible area, it is important that the repair blend as well as possible.

We glue the patch in using hot hide glue. As we have mentioned in other posts, hot hide glue is not only the traditional glue for veneer (and other) work, but has so many benefits it would be hard to think of doing this kind of work without it. For one, if we get the patch wrong (which we actually did) hot hide glue allows us to remove the patch without damaging the surrounding wood (the longer it cures though the longer it takes to re-gel). Once the patch meets our satisfaction we sand it level.
